Manhole Inspection Summary

Manhole # S37GG_019MH

Location Address: **1318 HOMEWOOD AVE**

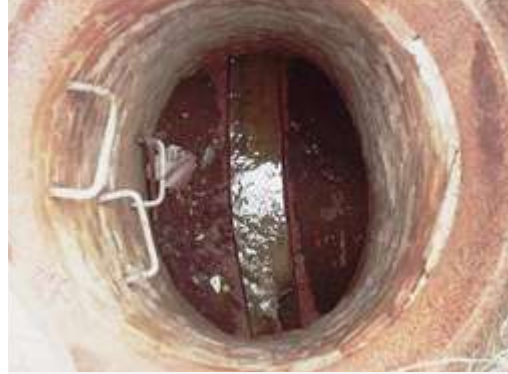
Top View

Barrel infiltration. Evidence of surcharge - Channel debris.

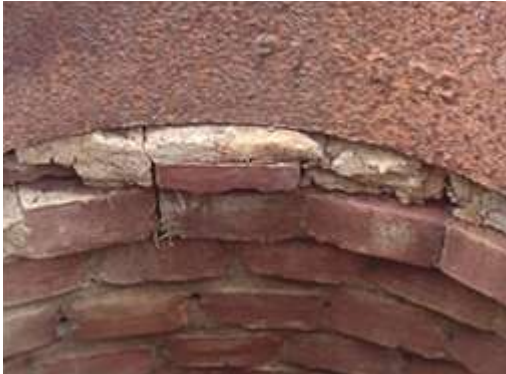
Defect

Adjustment deterioration, root intrusion, loose brick and infiltration.

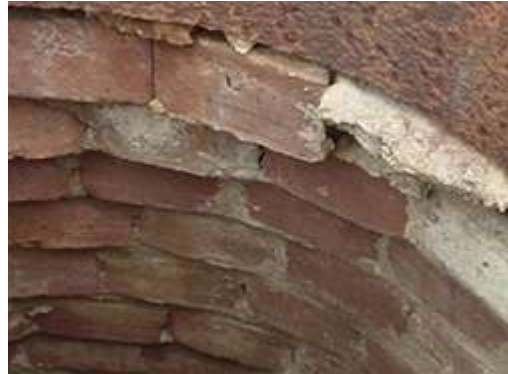
Defect

Adjustment deterioration and infiltration.

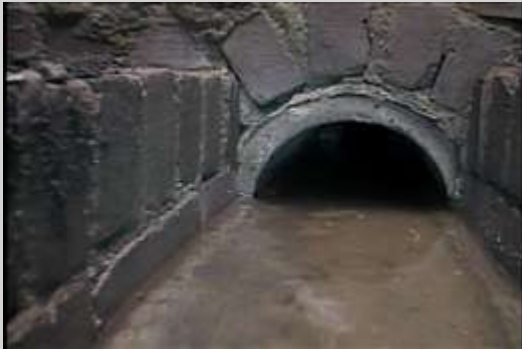
8 in. Circular Gravity Sewer Pipe Out @ 12 O'Clock

Deposits: ☐ None ☒ **Mud** ☐ Sludge ☒ **Debris** ☐ Grease

Infiltration: **Evidence** Pipe Seal Cond: **Unknown**

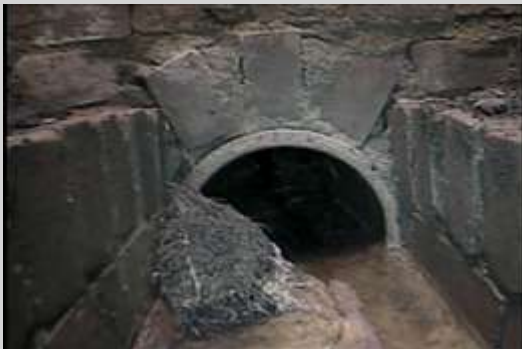
8 in. Circular Gravity Sewer Pipe In @ 5 O'Clock

Channel deterioration and root intrusion.

Infiltration: **None** Pipe Seal Cond: **Roots**
